INDOOR AIR QUALITY ASSESSMENT

**Samuel Bowles Elementary School
Bowles Park
Springfield, Massachusetts**

Prepared by:
Massachusetts Department of Public Health
Bureau of Environmental Health Assessment
February, 2002

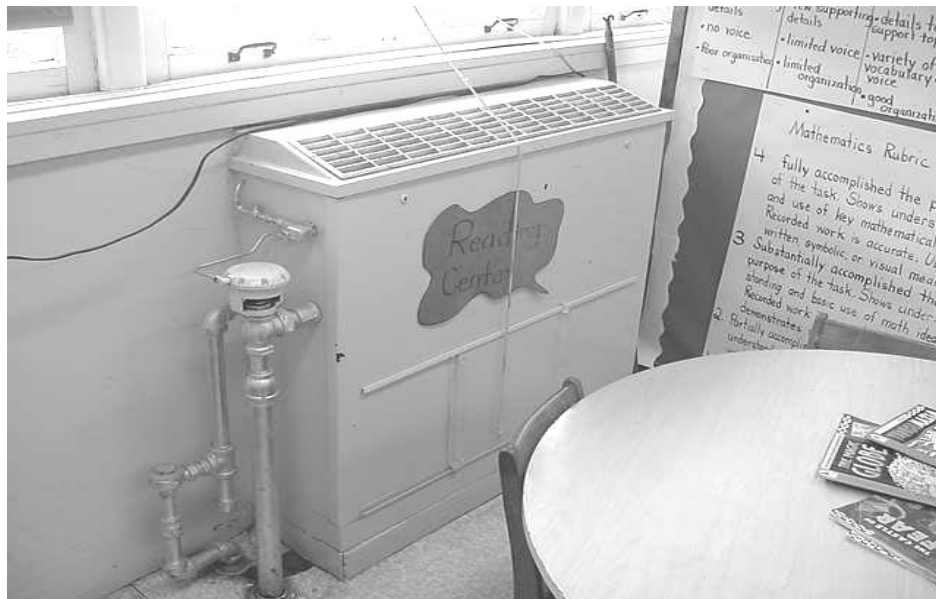
Picture 7

building (see Picture 7, Figure 1). Within each univent is a fan. Opposite the fan is a set of moveable louvers through which fresh air enters the univent. Controlling the amount of fresh air drawn into each univent is a sliding panel (see Picture 8). If the panel is slid to cover the return air vent entirely, the univent will draw 100 percent fresh air. Return air can be added as the panel is slid open. In order for univents to function as designed, univent fresh air diffusers and return vents must be unblocked and remain free of obstructions. Importantly, these units must be activated and allowed to operate.

Univent in the 1925 Wing

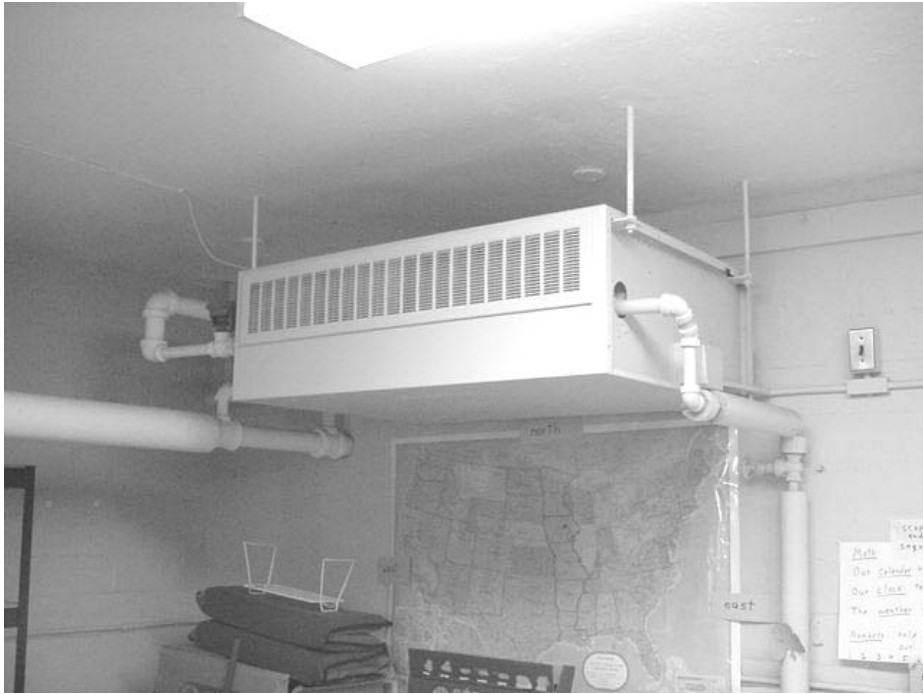
Picture 11

The 1954 and 1960s sections of the building (and classroom B) have fresh air provided by a univent system of a design dating back to the construction of the wing (see Picture 11, Figure 2). As with the older models, within each univent is a fan. Univents

Univent Installed in Classroom B

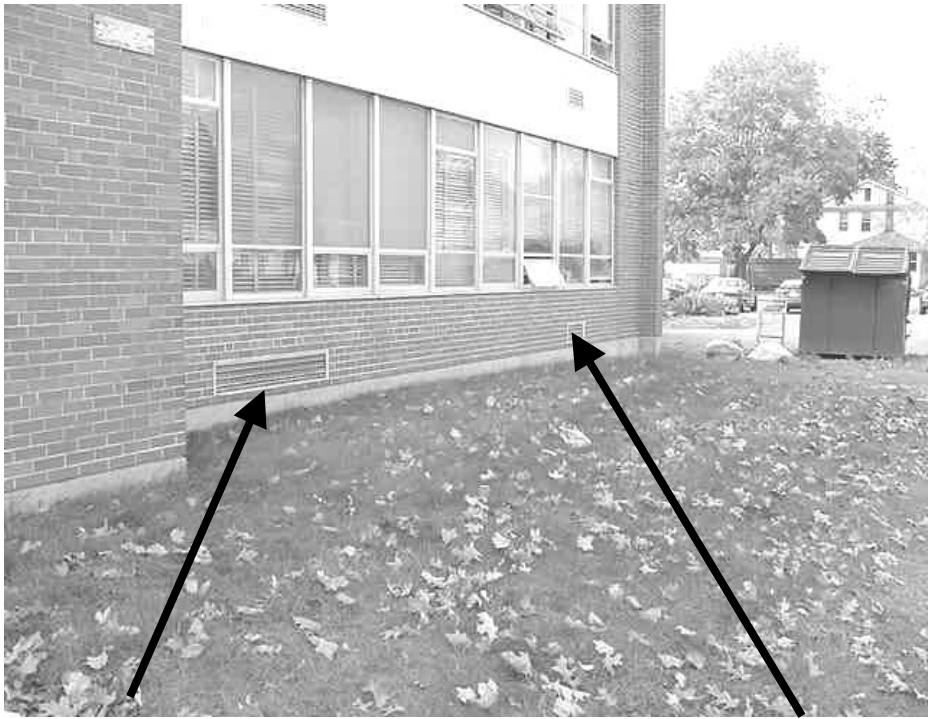
Picture 12

Fresh Air Intake

Exhaust Vent

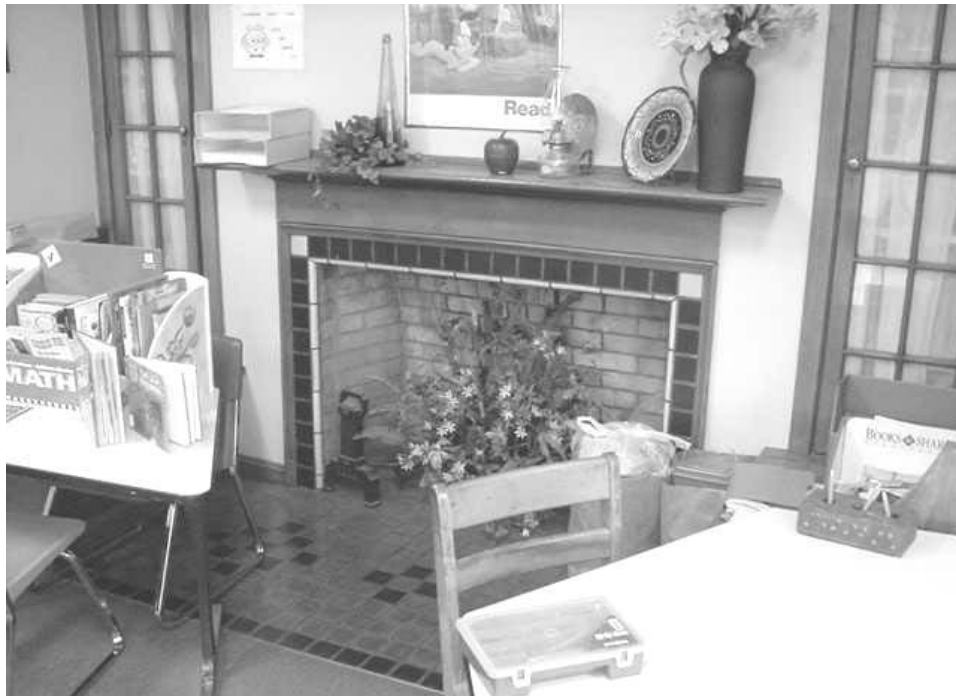
Picture 17

A fireplace exists in the library (see Picture 17) which appeared to be no longer in use. The chimney for the fireplace exists on the roof (see Picture 18). The top of the chimney is open, which can allow rainwater to penetrate down the shaft. In addition, animals may also enter the building through the chimney.

Unused Fireplace in the Library
